CASE REPORT

Mutilations: A Sad Story but Satisfactory Relief

ABSTRACT

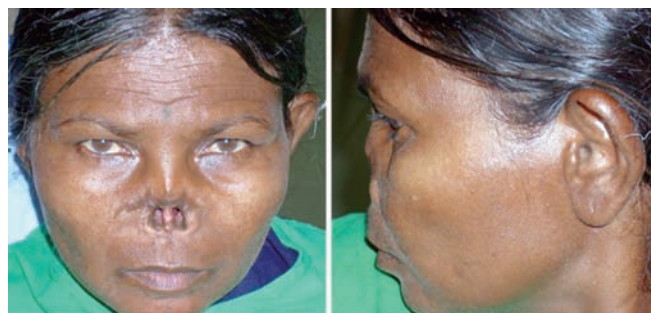
Fig. 1: Mutilated nose after healing

Midfacial defects may result from congenital or developmental abnormalities, accidental trauma, or acquired disfigurements due to removal of tumors during maxillectomy surgery.¹ There is also history of mutilation of the most extruding parts of the face (nose, ears, and lips) (Fig. 1). All these always lead to very severe impairment, not only of the body, but also of the individual's personality, since it results in a permanent alteration in the most noble and expressive part of the human body. The person had to attempt to overcome this situation in some way and the only way was to wear a mask or prosthesis, either fixed or removable, or attempt

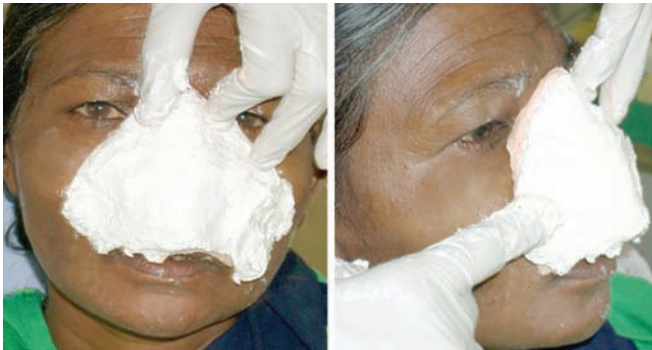
Fig. 2: Impressions made

The impression area along with the defect area was cleaned and coated with a petroleum jelly. The edges of the defect area were outlined using an indelible pencil and the vertical and horizontal lines are retraced on both the defect areas for positioning purposes. The modeling wax was used to make a box to contain the impression material. Alginate was mixed and poured on the defective area. Pieces of gauze were placed on the surface of the

alginate. Next a layer of fast set plaster was poured over the alginate to stabilize the alginate impression material. When the plaster was completely set, the impression was removed and poured in dental stone (Kalabhai Karson Pvt. Ltd.) (Fig. 2).

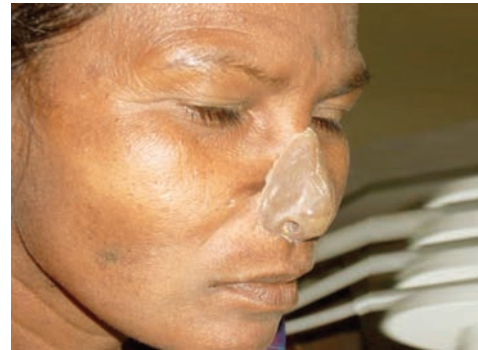
Fig. 3: Retentive acrylic attached to spectacle

An acrylic pattern was fabricated to the required shape. This was also made hollow to reduce the weight. Grooves were marked through the pattern to aid in silicone retention. A hook was incorporated in the substructure so that it could be attached to the spectacles at a later stage (Fig. 3).

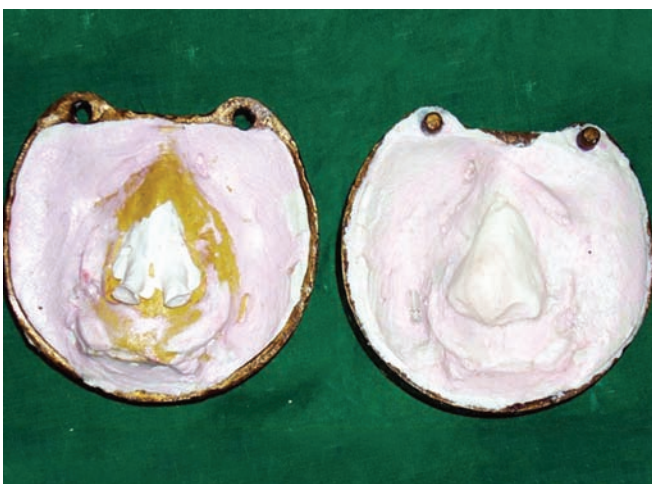
Fig. 4: After dewaxing

Later this wax pattern was flaked using dental stone and the mold achieved after dewaxing (Figs 4 and 5).

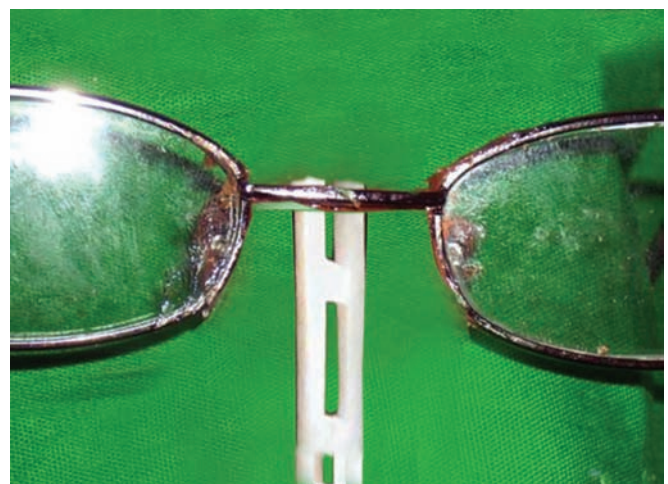
Fig. 5: Try in done

Pattern was fabricated by sculpting wax over the acrylic substructure. A satisfactory wax try in was done to check:

- The fit of the prosthesis on the tissue
- The correct horizontal and lateral alignment
- The integrity of the margins during simple jaw movements.

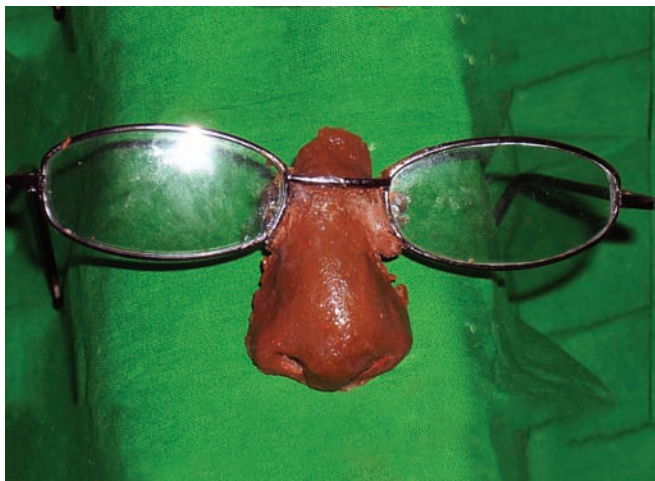
Fig. 6: Prosthesis attached to spectacle

Once the shade matching was completed, the material was packed and cured, for 48 hours at room temperature. Sharp scissors and scalpel blade were used to trim the residual flash. Extrinsic coloration was added to refine the color in the final prosthesis at the required area (Figs 6 and 7).³

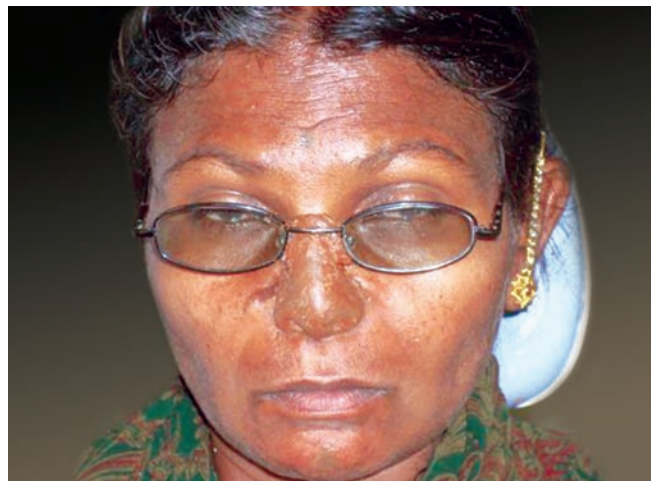
Fig. 7: Final prosthesis in place
