ESTHETIC CROWNS PRODUCE ALLERGIC GINGIVAL REACTION: A CASE REPORT

A 28 year - old female patient was referred to the Department of Periodontology for evaluation of inflammation of gingival tissue in the maxillary anterior teeth region around the porcelain fused metal crowns. Clinical examination revealed a severely inflamed hyperplastic tissue surrounding the maxillary incisor and canine while is well seen in Fig. 1. The patient had been aware of gingival condition for the last three months and it appeared to be getting continually bad. Probing depth in the region ranged from 3-5 mm with bleeding on probing in all areas. Careful evaluation of crown margins revealed that they were adopted in a clinically acceptable manner to the teeth and that an adequate physiologic zone existed for junctional epithelium and connective tissue attachment. The patient's medical history was essentially negative except for a history of allergies, she was presently taking an anti histamine(Cetirizine di hydrochloride) her dental history revealed a placement of porcelain –fused to metal veneer crowns on the maxillary six anterior teeth within the past six months. Due to the rapidity of onset and the sev

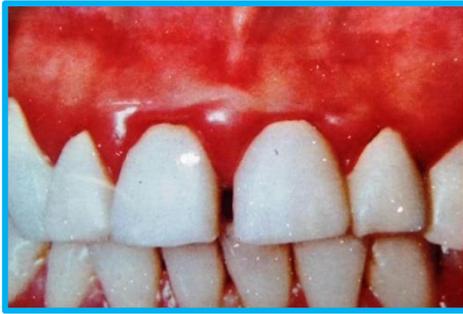
Fig. 1: Severely inflamed hyperplastic tissue surrounding the maxillary incisor and canine

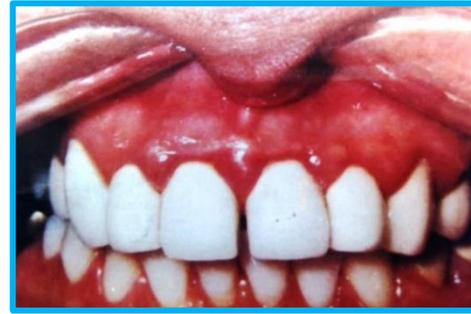
Fig. 2: Two months follow-up, provisional crowns fitted with polycarboxyl cement

replaced with acrylic provisional crowns fitted with polycarboxyl cement, which is seen in Fig. 2. Plaque control was reinforced and light subgingival instrumentation was performed at 2-4 weeks interval. One month following removal of the base-metal crowns, gingival shrinkage and color changes were evident Fig. 3. Three months later, more gingival resolution had taken place. The gingival tissue was pink and firm. Probing depth was acceptable and no bleeding was found upon probing Fig. 4.

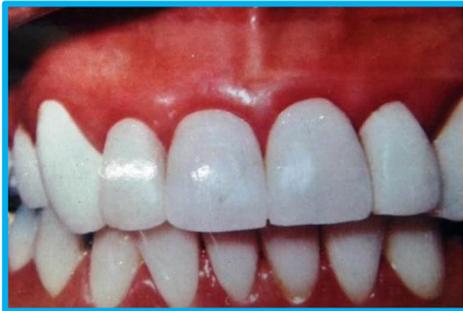
Fig. 3: One month following removal of the base-metal crowns

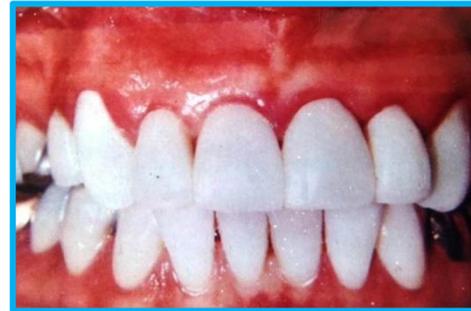
Fig. 4: After three months gingival tissues became more firm and pink
