## A COMPARATIVE EVALUATION OF SHEAR BOND STRENGTH OF ZIRCONIA CORE AND VENEERING CERAMICS OF TWO CAD/CAM SYSTEMS, CEREC AND LAVA- AN INVITRO STUDY

### ABSTRACT

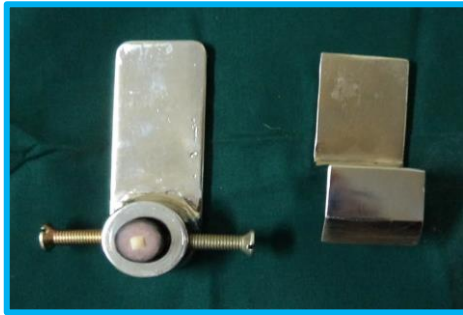
Fig. 1: A customized jig with sample placed in PVC pipe using cold cure acrylic

and ceramic interface (Fig. 2). The prepared samples were loaded on to UTM-INSTRON UNIVERSAL TESTING MACHINE. Samples were mounted on customised jig. The jig used has two components, one is attach to universal testing machine to apply force, the other component with the provision to place the poly vinyl chloride mounting cylinders in it and is attached to the universal testing machine to hold the specimen at the time of testing. Force was applied by a stainless steel jig until fracture occurred. Universal testing machine cross head speed was maintained at 0.5mm/min. the fracture load was measured and recorded by a digital monitor in Newton for all samples.

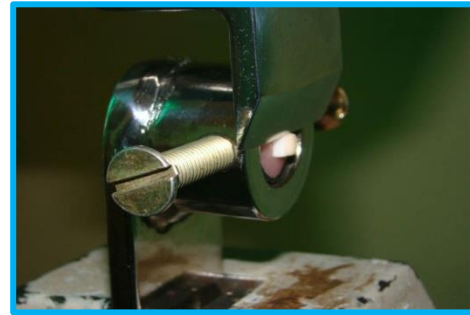
Fig. 2: Sample mounted in jig, subjected to force by universal testing machine

Porcelain build up was started according to the manufacturing instructions. Each zirconia sample was veneered with its own ceramic material. CEREC zirconia samples were veneered with Noritake. The irregularities and excess material were removed using micromotor hand piece. The blocks were cleaned in ultrasonic bath. Ceramic is layered onto the zirconia blocks with no additional surface treatment. Appropriate amount of ceramic powder and liquid is mixed to get a creamy consistency mix. Using a damp brush the mix is layered onto the surface of the zirconia blank. Ceramic build up was done upto 2mm. The ceramic is dried for 5 minutes then placed in a ceramic firing unit. Firing is done from temperature 600°C to 930°C under vacuum. Hold time under vacuum is 1 minute. Lava zirconia samples were veneered with LAVA ceramic. Similarly the LAVA blocks were checked for irregularities and cleaned in ultrasonic bath. Appropriate amount of ceramic powder and liquid is mixed to get a creamy consistency. Using damp brush the mix is layered onto the surface of zirconia sample. Thickness of ceramic build up was 2mm. The sample is then placed in a ceramic firing unit after drying it for 5 minutes. Firing is done from temperature 450°C to 800°C under vacuum. Hold time under vacuum is 1 minute. The fabricated zirconia block samples were mounted onto the Poly Vinyl Chloride (PVC) pipe and placed on to the jig to apply shear force. Poly vinyl chloride pipe was taken and cut into 40 pieces of uniform dimension measuring 2cms in length. Self cure acrylic resin is mixed according to manufacturer's instructions and poured in fluid stage into the pipe (Fig. 1). The samples were later embedded along their vertical alignment so that ceramic build up is above the top of the standard PVC mounting cylinders. This is done to ensure the application of force is at the zirconia

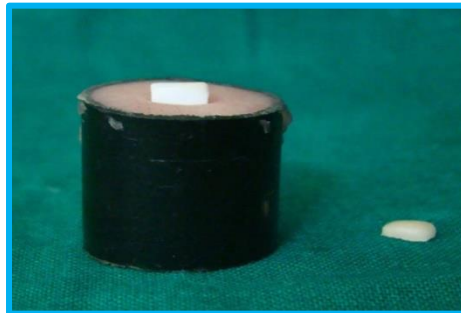
Fig. 3: Sample after subjecting to shear load in universal testing machine

This study consisted of total 40 samples, 20 samples belonging to group A (CEREC) and 20 samples belonging to group B (LAVA). The ultimate load at which the delamination of ceramic occurred was recorded in Newtons and the shear bond strengths were calculated in Megapascals (MPa) by dividing the load (N) at which failure occurred by the bonding area (mm<sup>2</sup>). Shear stress (MPa) = Load (N)/ Area (mm<sup>2</sup>) Where bonding area is calculated by formula length x breadth i.e., Area = 5mm x 4mm = 20mm<sup>2</sup>. Table I and II illustrates the amount of force applied and stress of displacement of group A and group B respectively. In group A the maximum shear strength recorded was 7.78 MPa and the amount of load required to delaminate the ceramic is 155.6N. In group B the maximum shear strength recorded was 18.45 MPa, and the amount of load required to delaminate the ceramic is 370.9N. In group A the minimum shear strength recorded was 4.05MPa, the amount of load required to delaminate the ceramic was 81.18N. In group B the minimum shear strength recorded was 1.80MPa, the amount of load required to delaminate the ceramic was 36.14N. Statistical test used for analysis is unpaired t- test. According to Null Hypothesis there was no significant difference in the mean shear bond strength between two systems, however in Alternate Hypothesis significant difference was found in the mean shear bond strength between the two systems. Higher mean shear bond strength is recorded in group B when compared to group A.
